Town of Mammoth Lakes Erosion, Drainage, and Flooding Project

FINAL RECOMMENDATIONS REPORT

April 11, 2008

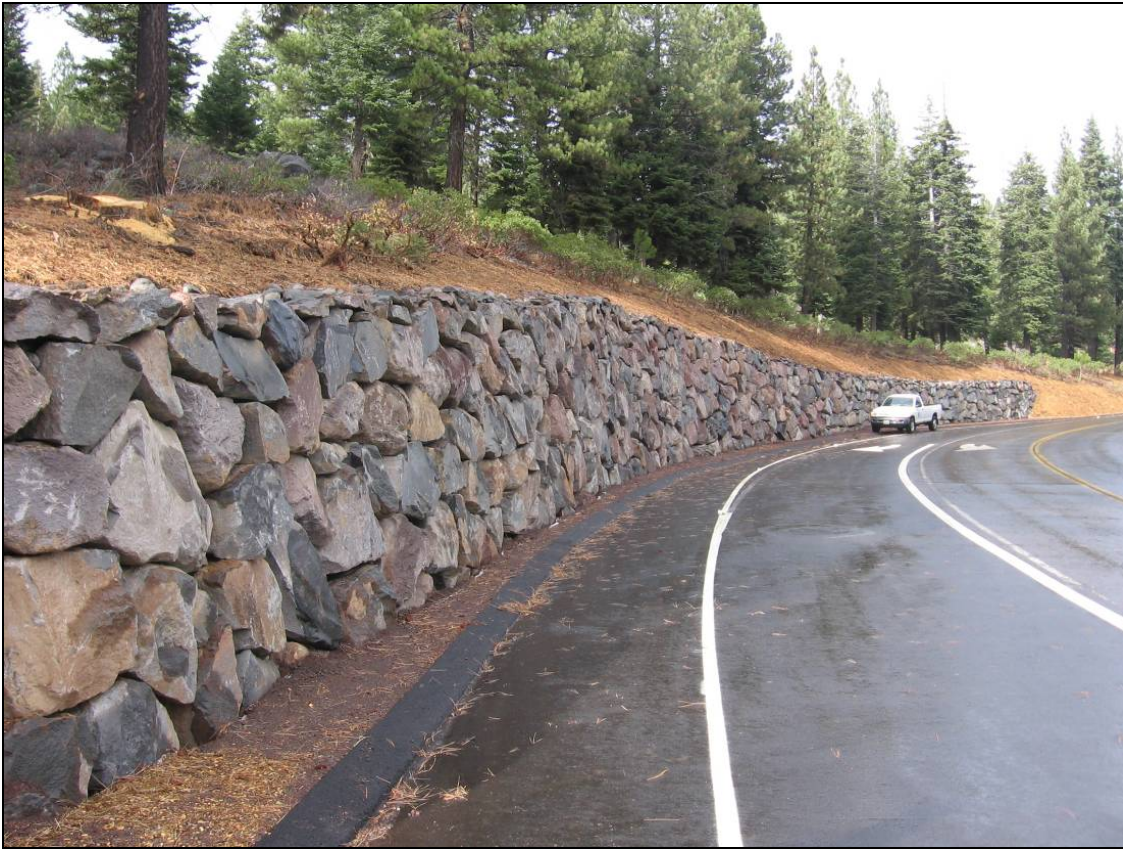
Figure 3.3 - Rock Retaining Wall Photo

- Subsurface soil, rock, and groundwater conditions will strongly control the selection of the appropriate wall type, material and design and should be further evaluated within the context of a geotechnical investigation.

- Ensure there are no concentrated surface water discharge points above the wall.
- Construction equipment access may influence the type of retention system is utilized.

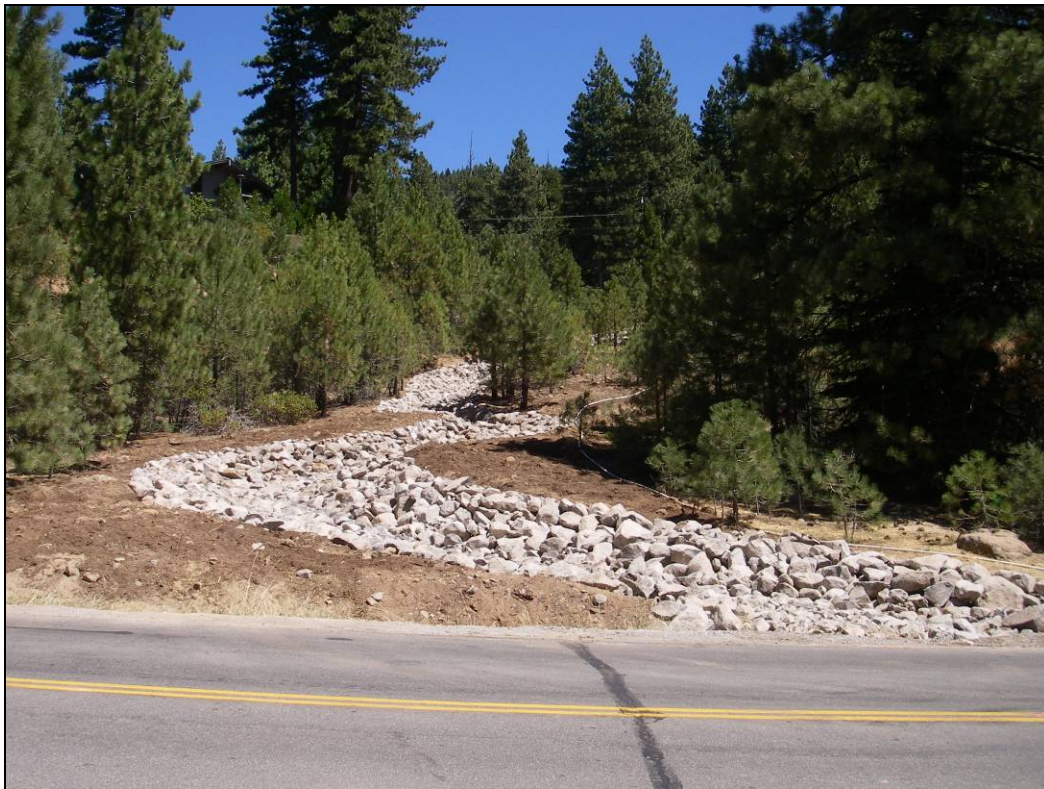
Figure 3.9 - Rock Lined Channel Photo

Design Considerations (Figure 3.9):

- Generally deployed in channels with an average slope of >5% (CASQA 2003).
- Hydrologic and hydraulic analysis is required to determine peak flows, velocity and shear stress.
- Critical to select rock size (D_{50}) which will be immobile during the largest flow events (100 year flood).
- Angular rock provides greater surface roughness as compared to smooth or round rock.
- Use solid and durable rock material that can withstand the freeze thaw cycles of the High Sierra (City of Reno 2003).
- Place riprap so it extends to the maximum flow depth, or to a point where vegetation will be satisfactory to control erosion (EPA 2008).

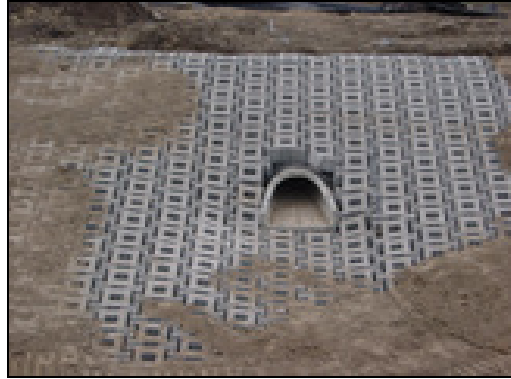
Figure 3.10- Picture of Armorloc as outlet protection

Design Considerations (Figure 3.10):

- Generally, require that a woven geotextile be placed between the native soil surface and the bottom of the eco block unit(s).
- Void space can be filled with drain rock or soil depending on site specific conditions. In areas with continuous high velocity flows, larger drain rock is recommended.
- When slopes are steep it is recommended that the units are held together with cable or staked at a specified frequency.
- Eco blocks are relatively new in the Sierra and NCE recommends the Town consult the manufacture's design staff prior to specifying this product for a project.

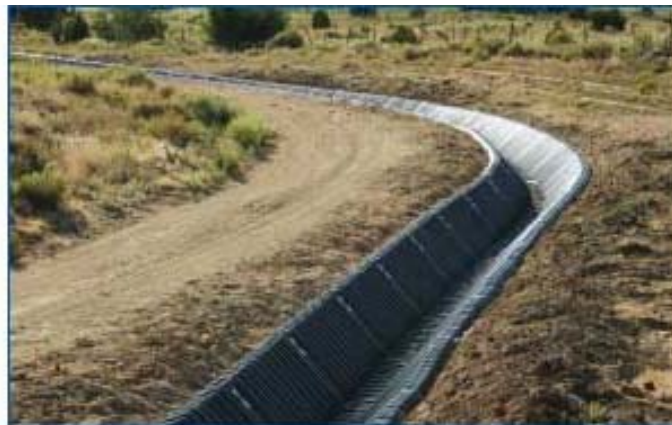
Figure 3.11- Picture of Smartditch (www.smartditch.com/index.htm)

Design Considerations (Figure 3.11):

- Most products have a minimum flow velocity required to maintain self scouring and eliminate sedimentation in the prefabricated channel.
- Not recommended in locations where riparian vegetation or riparian habitat are desired.

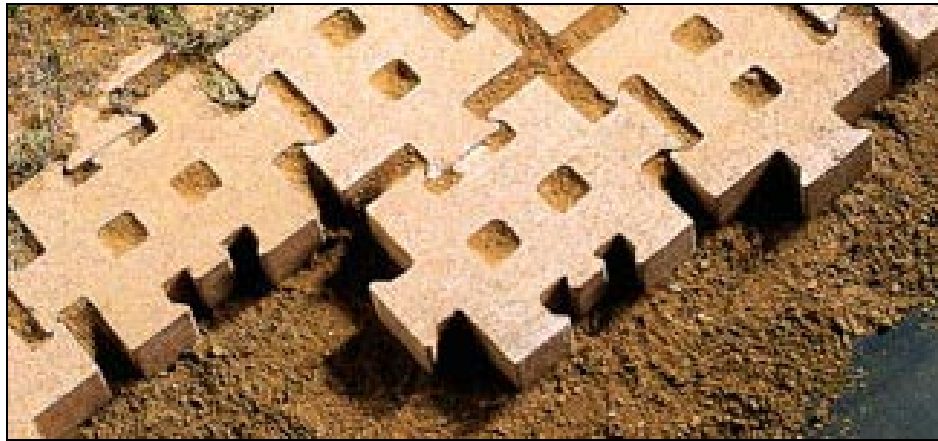
Figure 3.12 - Picture of the Pavestone Conlock II

Design Considerations (Figure 3.12):

- Some products are not designed to handle loading from vehicles. Consult the manufacturer before specifying on any project.
- Generally, require that a woven geotextile be placed between the native soil surface and the bottom of the eco block unit(s).
- Void space can be filled with drain rock or soil depending on site specific conditions. In areas with continuous high velocity flows, larger drain rock is recommended.
- When slopes are steep, it is recommended that the units are held together with cable or staked at a specified frequency.
- Eco blocks are relatively new in the Sierra and NCE recommends the Town consult the manufacturers prior to specifying this product in future projects.

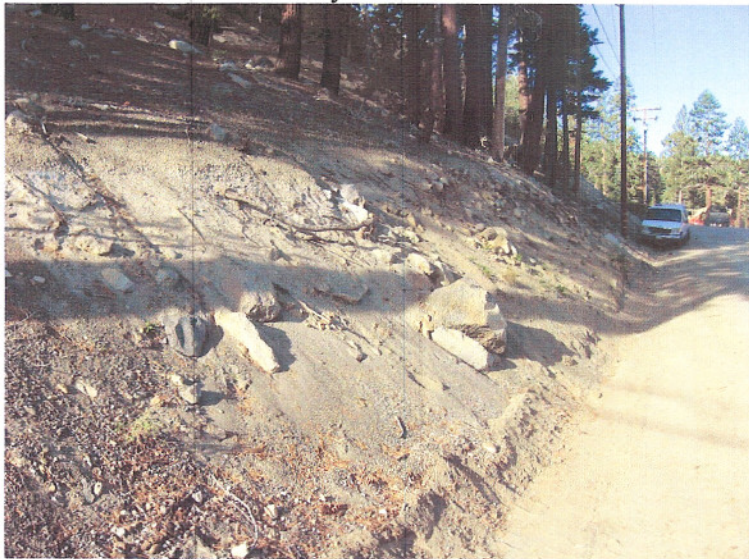
Photograph – Road Cut #1

The sloped area around John Muir Road that is contained within the project limits shown on Figure 2 is generally developed residential parcels on forested land with steep topography. The area slopes steeply down to the north with elevations ranging from approximately 8400 to 8700 feet above mean sea level with slopes generally ranging from about 5% to 50%. However, as John Muir Road makes switch backs up the road, there are two road cuts that are significantly steeper slopes. The first lower road cut slope (Road Cut #1, shown on Figure 2) and in the photograph below is approximately 10 to 20 feet high and ranges in slope from 40% to 60%. The slope is bounded above and below by John Muir Road.

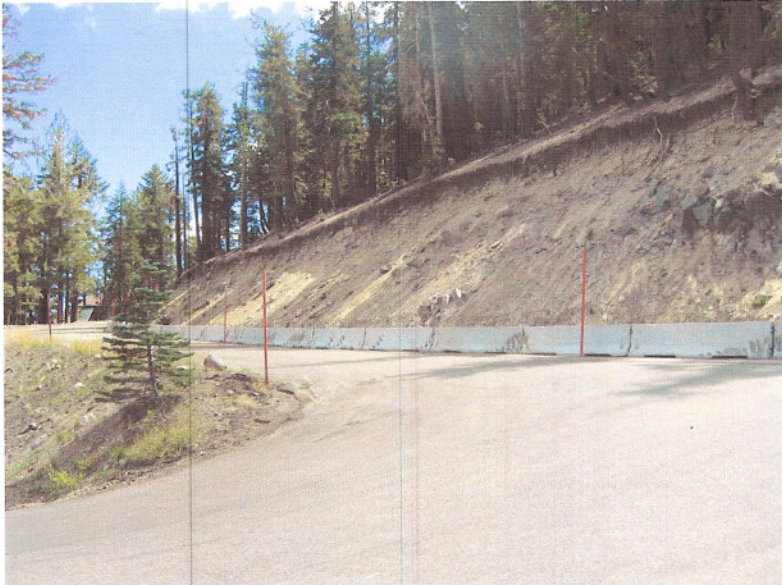
Photograph – Road Cut #2

The second upper road (Road Cut #2), shown on Figure 2 and in the photograph below, is quite large and is approximately 20 to 25 feet high with a slope of approximately 40% near the toe and steepens to a 2-foot near vertical section at the top. Near this vertical location soil is being stabilized by the tree root zone. The closest structure upslope of this cut slope is a condominium complex which is approximately 130 feet upslope to the closest edge (northeast corner of the building). Active erosion was apparent at both slopes, especially at the second larger road cut. The Town indicates that the slope requires periodic maintenance to remove soil/rock material and fallen trees behind the K-rail at the base the slope due to slope erosion.
